APPENDIX B

EXISTING REACH CONDITIONS AND DATA SUMMARY

The State of Montana Department of Justice Natural Resources Damage Program (NRDP) retained WestWater Consultants, Inc. (WWC) to conduct a detailed existing conditions assessment of the Clark Fork River (CFR) and Blackfoot River (BFR) in the vicinity of Milltown Dam near Bonner, Montana. The primary goal of the project was to refine and validate the Draft Conceptual Restoration Plan for the Clark Fork River and Blackfoot River near Milltown Dam (DCRP) prepared in 2003 by Water Consulting, Inc. and Wildland Hydrology. The DCRP developed a coarse level approach to restoration of the Clark Fork and Blackfoot rivers based on limited field data and information. To supplement existing information and provide a robust data set from which to finalize a restoration plan for river reaches associated with the Milltown Reservoir Sediments Operable Unit (MRSOU), a Sampling and Analysis Plan (SAP) was developed by NRDP and WWC. The SAP was implemented in 2004-2005 by WWC and River Design Group, Inc. (RDG). This report presents and summarizes the methods and results of the data collection and analysis effort.

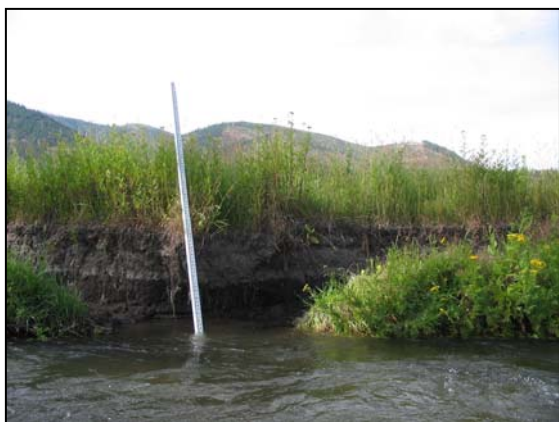
Figure B-6. Typical bank condition in CFR3-A. Note lack of woody vegetation and dominance of noxious weed s.

Thirty percent (30%) of the surveyed banks rated high in terms of bank erosion potential, 53% very high, and 17% extreme. The frequency of eroding banks appeared to correlate with degraded vegetation conditions on the floodplains and low terraces.

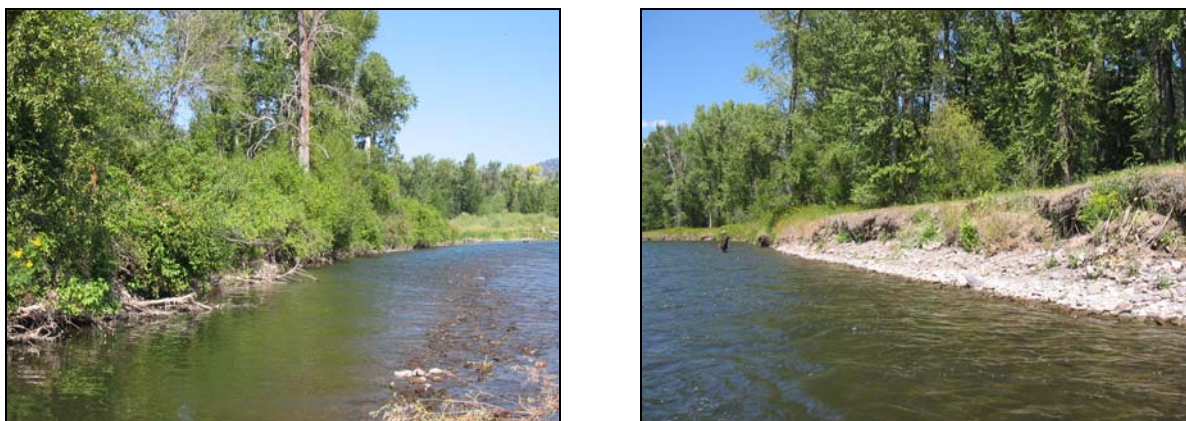
Figure B-10. Photos of representative streambank conditions within CFR3-B.

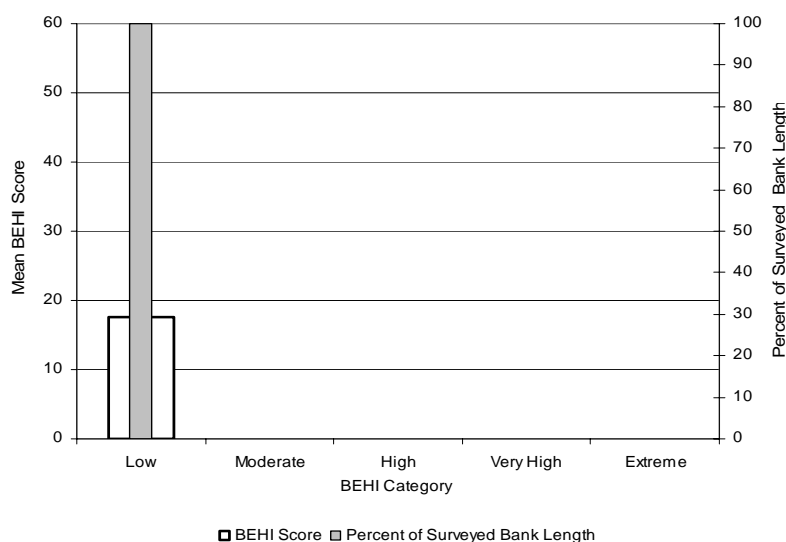
The bank integrity analysis included an evaluation of four bank sites with a total surveyed bank length of approximately 2,900 ft within CFR at Bandmann Flats. Figure B-17 summarizes the results for CFR at Bandmann Flats. Bank erosion potential at all sampled sites was low. Numeric BEHI ratings included 19.2 at Site 1, 19.1 at Site 2, 15.8 at Site 3 and 16.4 at Site 4.

Figure B-17. BEHI scores and ratings for representative bank condition sites in CFR1 at Bandmann Flats.

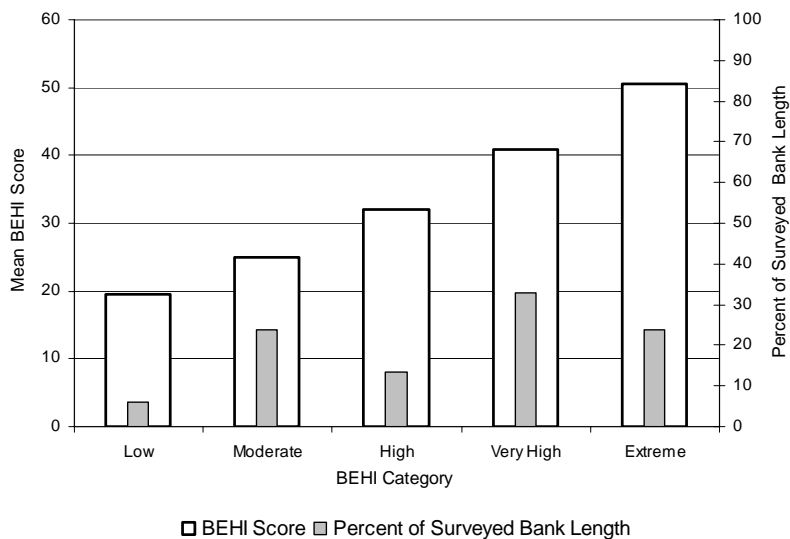
In low gradient, unconfined reaches such as CFR3, loss of bank integrity can result in dramatic channel widening (Montgomery and Buffington, 1993). The effects of vegetation conversion within CFR3-A and CFR3-C, compounded by historical flood events and other impacts, are accelerating rates of bank erosion and lateral channel migration. In general, floodplain and streambank vegetation communities are of younger age classes and in many instances composed of noxious weed and agricultural types, offering minimal streambank stability compared to the historical vegetation communities that were characterized by forested riparian plant communities including non-climax cottonwood/ red osier dogwood interspersed with conifer dominated climax communities such as the Ponderosa pine/red osier dogwood (*Pinus ponderosa*/*Cornus stolonifera*) or Douglas fir/red osier dogwood (*Pseudotsuga menziesii*/*Cornus stolonifera*) habitat types (Hansen et al., 1995). Overall, bank erosion potential in CFR3 ranged from moderate to extreme. The distribution of conditions included low (6%), moderate (24%), high (13%), very high (33%) and extreme (24%) (Figure B-18). High to extreme ratings were associated with the braided channel regimes. Low to moderate ratings were found in the CFR3-B reference reach, where vegetation was more dominated by historical cover types providing increased bank integrity and resistance to erosion. The planform morphology and stability of the reaches likewise reflected the prevailing vegetation conditions and sediment regimes. CFR3-B, characterized by low to moderate sediment supply, maintained a meandering plan form with a defined dominant bankfull channel and active flood channels whereas CFR3-A and CFR3-AC were braided and unstable with frequent deposition of bars and high sediment supply.

Figure B-18. BEHI scores and ratings for all representative bank condition sites in CFR3.

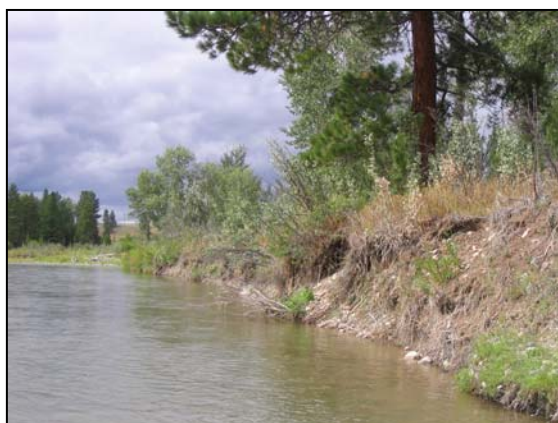
Bank material composition was primarily gravel with a high fraction of sand and unstable strata. Figure B-22 includes photos of a representative streambank conditions in Reach 1.

Figure B-22. Typical streambank condition in Reach 1 of the BFR near Ovando study area. This site rated moderate in terms of bank erodability potential.

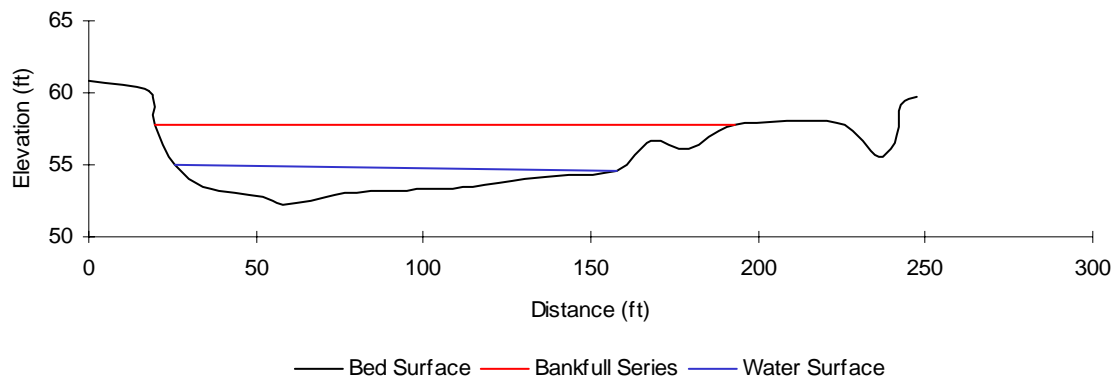
Nine channel cross-sections were surveyed in Reach 2. Four cross-sections were surveyed in riffle units and two in run and glide units. Due to the relatively short reach length, only one pool was observed. Bankfull riffle habitat unit widths ranged from 178 ft to 217 ft, with corresponding width-to-depth ratios ranging from 38-73, respectively. Maximum riffle depths ranged from 3.8 ft to 5.6 ft with an average value of 4.7 ft. Average bankfull cross-sectional area for riffle habitat units was 575 ft², ranging from 498 ft² to 655 ft². Table B-37 summarizes the data. Figure B-23 depicts a typical riffle cross-section.

Bankfull pool width was 177 ft with a maximum depth of 7.9 ft. Pool bankfull cross-sectional area was 633 ft². Bankfull glide widths ranged from 143 ft to 153 ft, with average depths ranging from 3.6 ft to 3.7 ft. Runs were identified as areas where the profile transitions from riffle to pool habitat units. Average run cross-sectional area was 600 ft². Bankfull run widths ranged from 152 ft to 161 feet with mean depths of 3.4 ft to 4.3 ft.

Figure B-23. Typical riffle cross-section in Reach 2 of the BFR near Ovando.

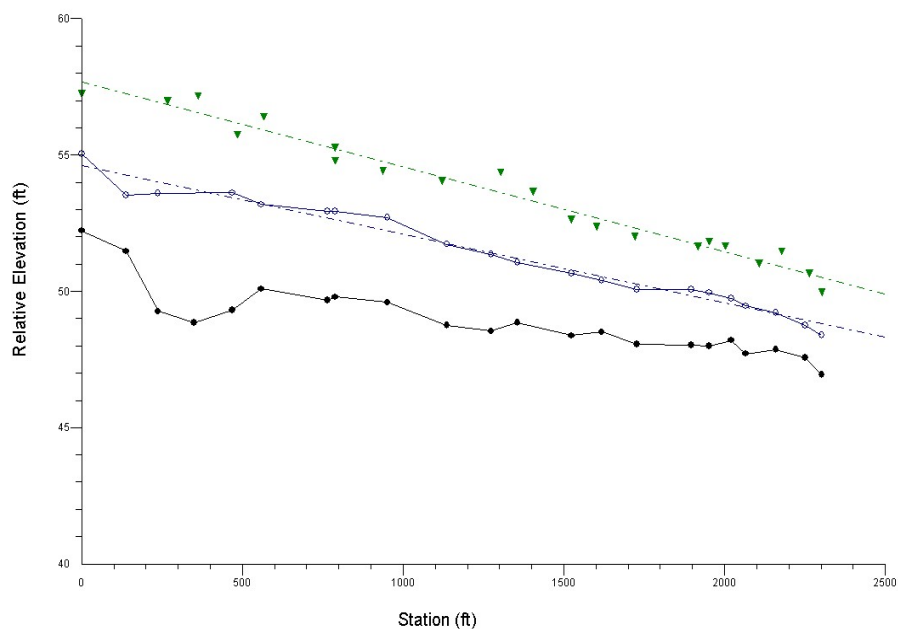
Longitudinal profile data were collected on a 2,300 ft representative segment of Reach 2. Features including channel thalweg, water surface, and bankfull floodplains were surveyed to characterize the channel profile. Bedform morphology was characterized by riffles and irregularly spaced scour pools associated with large cobble and boulder lag deposits. Figure B-24 presents the longitudinal profile graph. As noted, the profile was fairly homogenous with a majority of the habitat composed of riffle and run morphology.

Figure B-24. Longitudinal channel profile graph depicting dominant bed morphology, water surface facet slopes, and bankfull features within Reach 2. The green points represent the bankfull floodplain with a best-fit line, the blue points are the water surface with a best-fit line, and the black points represent the thalweg.

Longitudinal channel profile data are summarized in Table B-38 and B-39. Average water surface slope was 0.0025 ft/ft. Average riffle and pool slopes were 0.0053 ft/ft and 0.0008 ft/ft respectively. Riffle slopes were over-steepened by approximately 210% relative to the average water surface slope, and pools were flatter or approximately 30% of the average water surface slope. The ratios of riffle and pool slopes to average slope were 2.12 and 0.32, respectively.

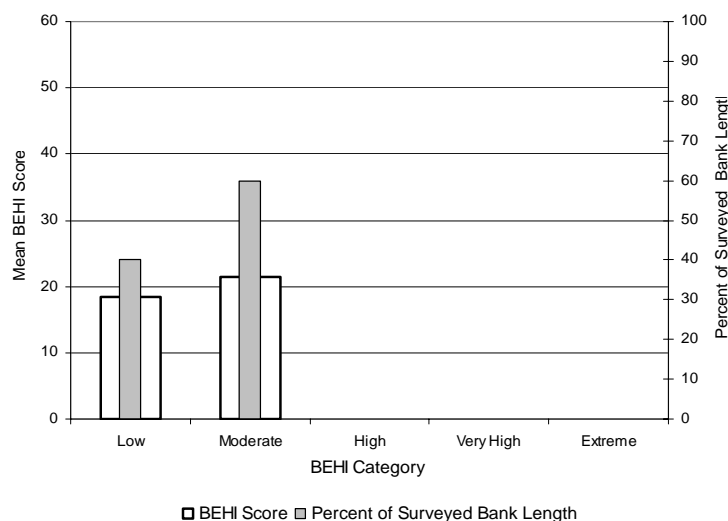
conditions within Reach 3, including bedrock formed hillslopes and unconsolidated glacial till and lacustrine mantled slopes (Figure B-29). Figure B-30 summarizes the results. Bank erosion potential for the reach was low to moderate. Slopes mantled with till and finer grained sediments were typically well vegetated offering sufficient bank surface protection from high flows. Numeric BEHI ratings included 18.4 at Site 1 and 21.5 at Site 2.

Figure B-30. BEHI scores and ratings for representative bank condition sites in Reach 3.

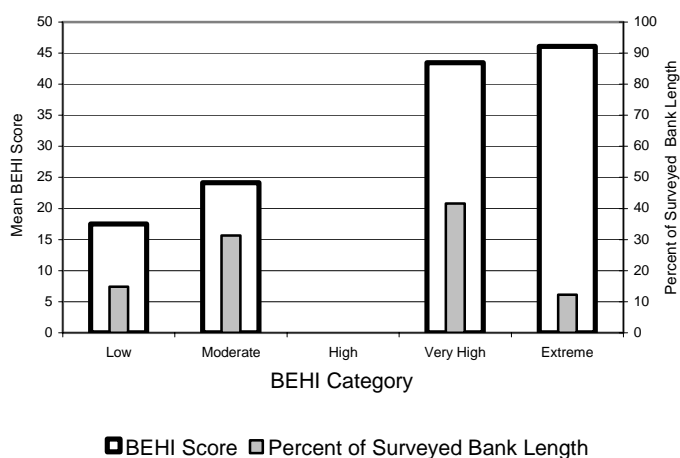
Figure B-35. Composite BEHI scores and ratings for the Blackfoot River near Ovando, Reaches 1, 2 and 3.
